Technical Bulletin

TB-58-99
5-21-99

Subject: 02023-0039 Steer Axle Thrust Bearing

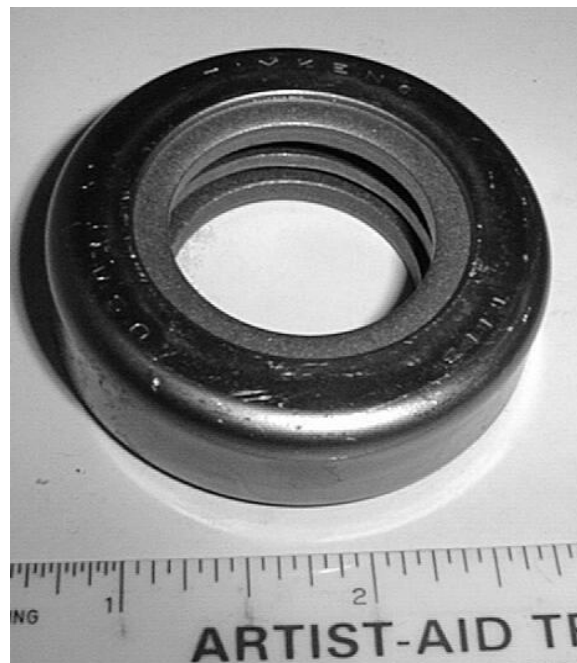
Using a bearing grease press, pack the bearing topside down. Install the bearing with the bearing cage up as seen in the attached photo, if installed otherwise it will be possible for water or other contaminants the collect and seep into the bearing case.

Procedure for greasing of new steer axle thrust bearings before installation.
